River Nar Monitoring

Review of Pre-river Restoration Monitoring Results on Mileham Common and Meadow

Helen Mandley
April 2013

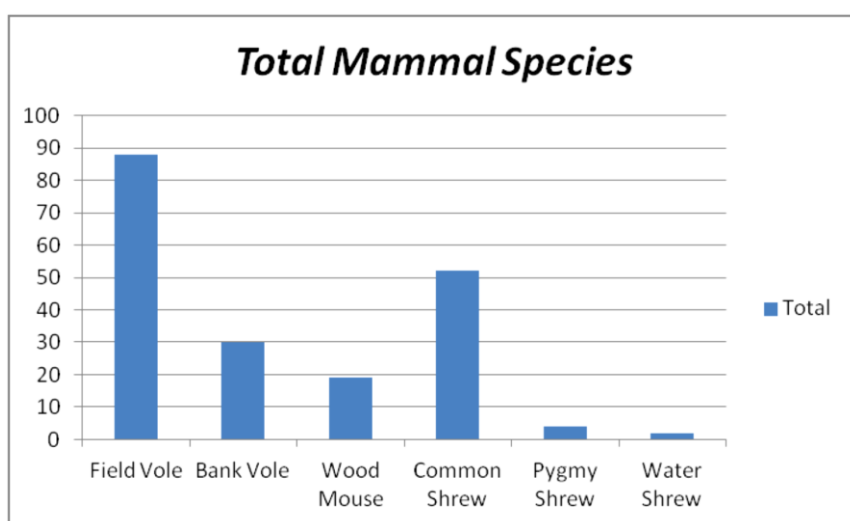
Bar chart 1: Chart showing total mammal species for the Meadow and Mileham Common

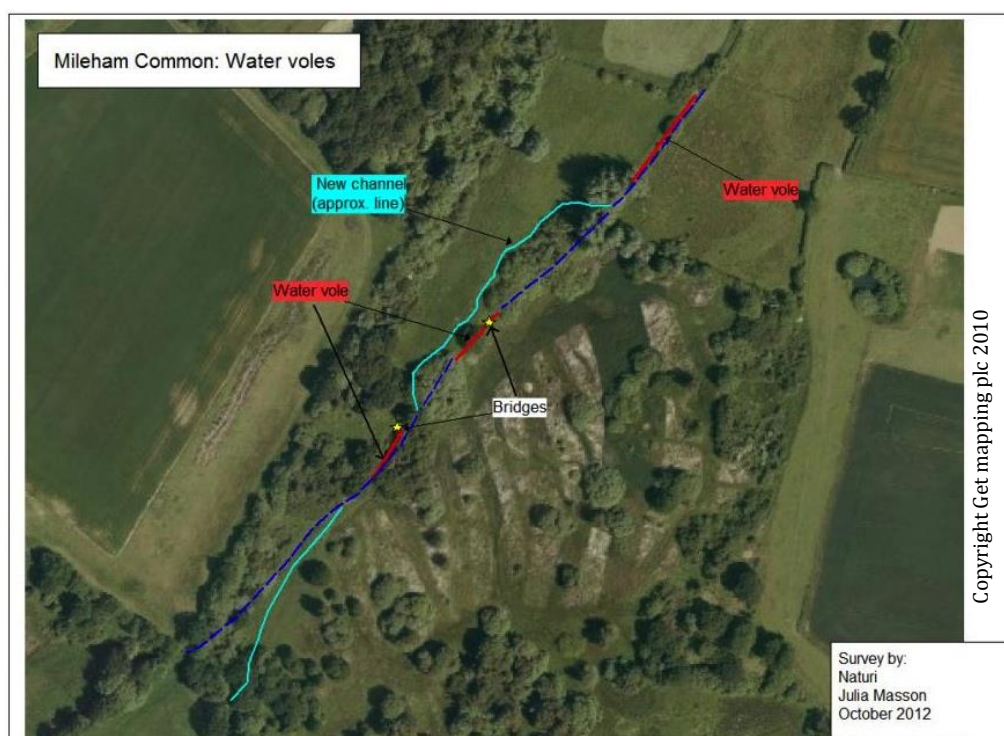
3.6 Plate 3 shows the location of water vole burrows, latrines and feeding stations found on Mileham Common (red line). The map also shows the proposed route for the new channel, avoiding water vole stretches (blue line).

Plate 6: Water Voles on Mileham Common

3.4 Mileham Common: Four out of the 6 floating polystyrene rafts contained evidence of water voles where they were using the rafts as feeding stations and latrines. There were also natural latrines and there was an estimate of 20 water vole burrows found on the riverbank (please see Plate 3 which shows the location of evidence of water voles).

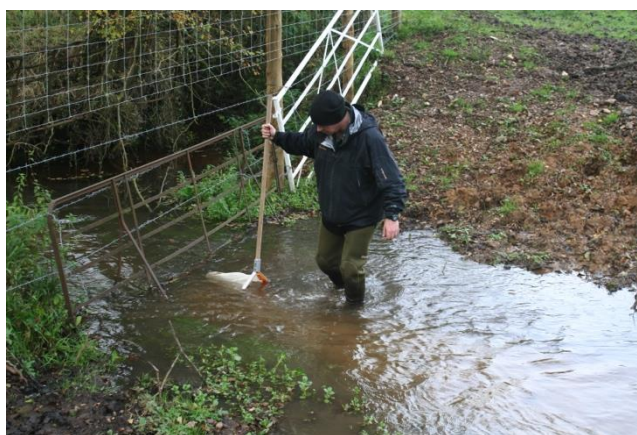
Plate 7: Mark Rylands (RES) kick sampling (Plot 3)

4.2 Sampling method: Three sites were chosen within the incised channel of the River Nar where they were visited once a month (Plot 1 = Common, Plot 2 and 3 = meadow). These samples were collected by using a kick sampling technique where the net (1mm mesh) is placed downstream on the riverbed and using your foot to disturb the riverbed just upstream of the net for 3 minutes to dislodge any invertebrates which are then carried by the current downstream into the net.

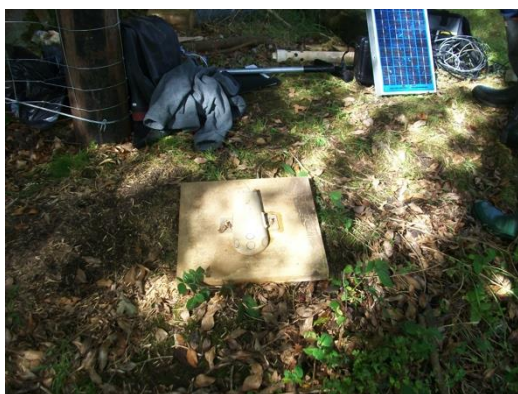
Plate 13: The EA flow meter on the riverbank.

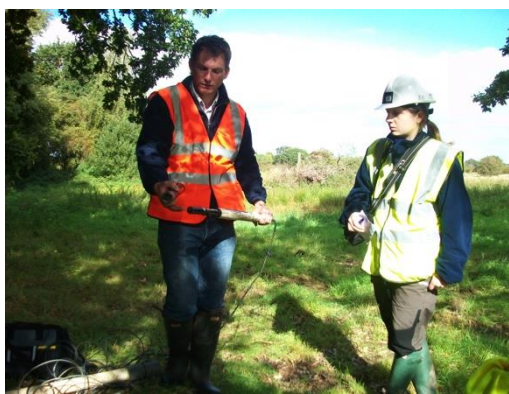
Plate 14: Matthew Ellison (OTT) explaining the monitoring sonde.

A range of telemetry equipment including a Hydrolab was installed by EA and OTT to provide a period of continuous data for the river restoration project covering river flow, dissolved oxygen (DO) (taken as % saturation), flow velocity, pH, temperature and conductivity. Data was collected at 15 minute intervals and downloaded onto IQ software for analysis.

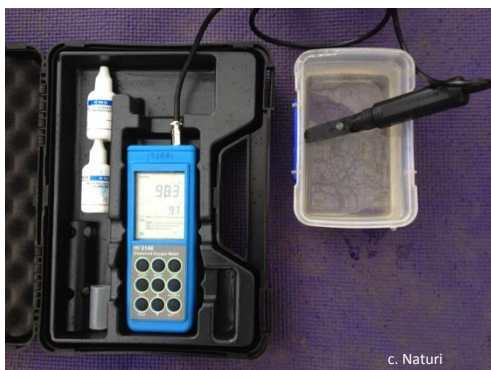
Plate 15: Hand-held dissolved oxygen meter.

6.6 In addition, DO measurements were taken on a weekly basis from August using a hand-held Hannah Instruments Dissolved Oxygen and Temperature Meter (HI 9146) provided by the Norfolk Rivers Trust.

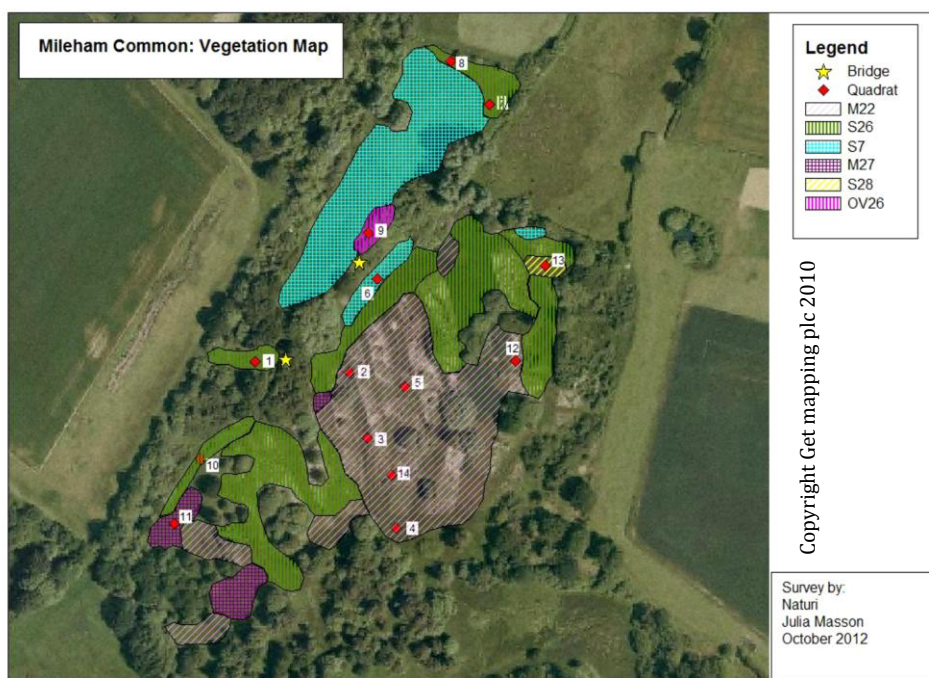
Plate 16: The vegetation survey map of Mileham Common.

7.2 Survey Method used: Aerial photographs from 2010 were used to aid navigation around the site, which was dominated by tall, largely unmanaged vegetation amongst tree and shrub scrub. They were also used for mapping the vegetation community types across the common using the British Plant Community coding, National Vegetation Community (NVC).

Table 1: Six vegetation types that were recoded in Mileham Common (Plate 11).
