Working with an outdoor pig unit to reduce soil & water pollution

Wayland Farms, West Acre, Norfolk

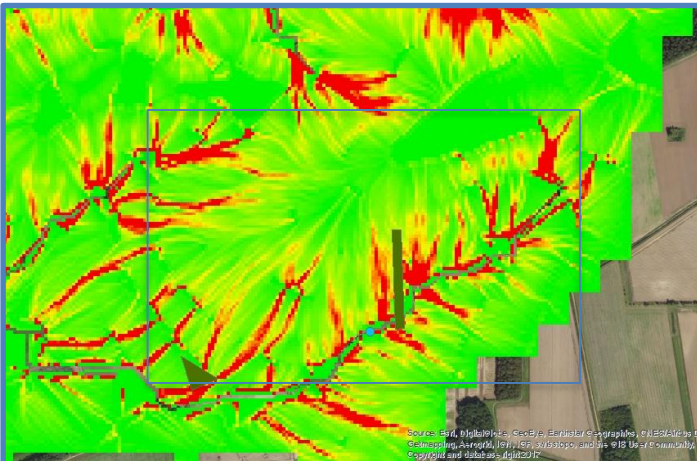
Figure 2. Diffuse pollution risk mapping (SCIMAP: red = high risk and green = low risk) of Wayland Farms (blue box).

An assessment of the site - using mapping (Figure 2), visual observations during a walkover and farmer knowledge – was conducted to identify locations where runoff was likely to occur. The analysis takes into account land use, soil type, rainfall and connectivity through pathways to the receptor.

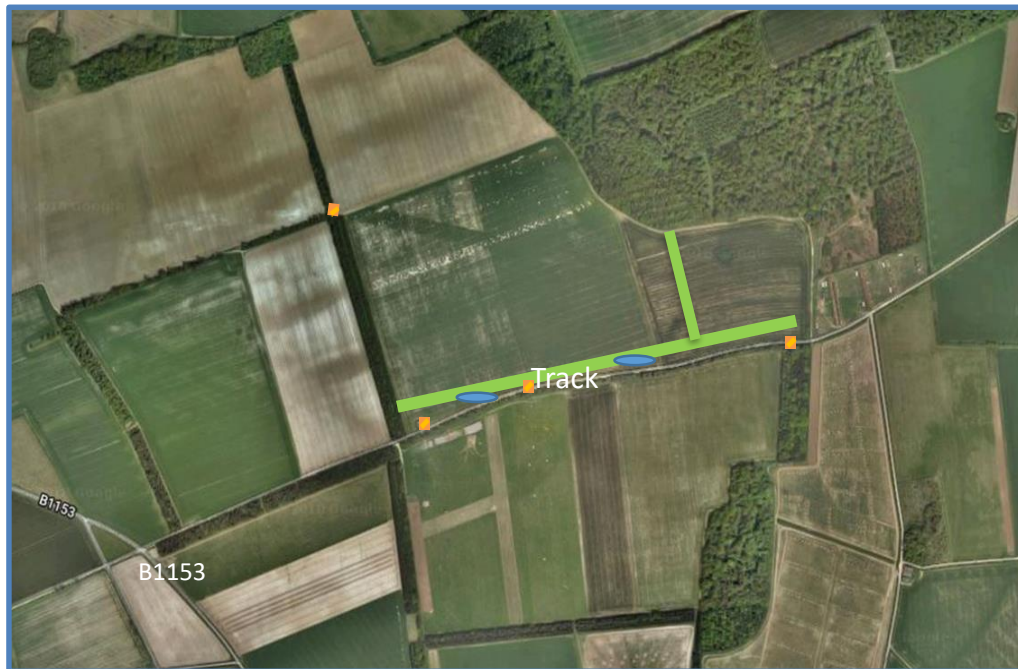
Since the field has a gentle slope, the run-off flows down to the farm track, which leads onto the B1153 road, where it could eventually reach the watercourse (Figure 3).

Figure 3. Locations for silt traps, buffer strips and track humps.

It was decided that two silt traps would be installed at the site (Figures 3, 4 & 5) with grant funding through the Water Sensitive Farming initiative. The traps work by capturing and slowing down polluted run-off, which enables the sediment and suspended solids to settle out. This is important as the solids can have pollutants such as nitrates and phosphates attached to them.

A couple of buffer strips were also implemented to reduce run-off and provide an extra habitat. In addition, track restoration work also took place to trap run-off e.g. hump and cross-drain construction (Figure 3). The accumulated sediments are then returned to the field where it will benefit the farm.

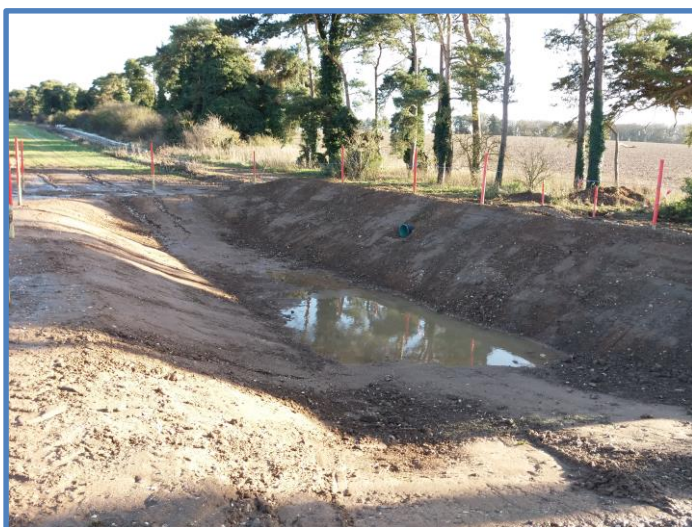
Figure 4. Silt trap (1) installed in December 2017.

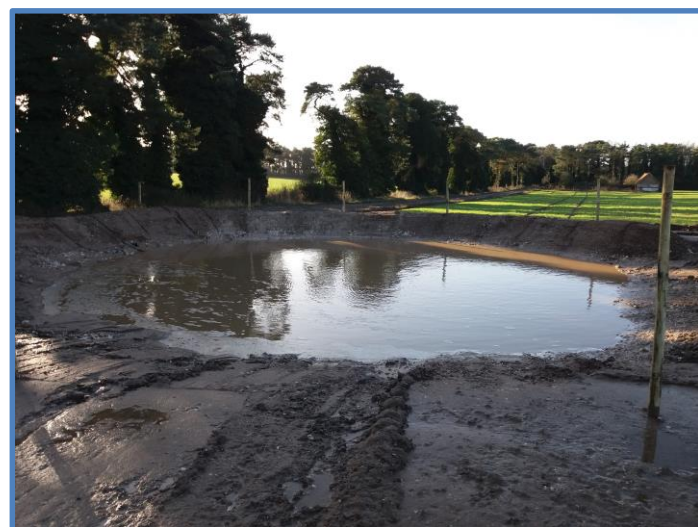
Figure 5. Silt trap (2) installed in December 2017, complete and capturing run off.
