THE NORFOLK RIVERS TRUST  
RESTORING NORFOLK'S RIVERS

# THE RIVER BURN

A WATER FRAMEWORK DIRECTIVE LOCAL CATCHMENT PLAN

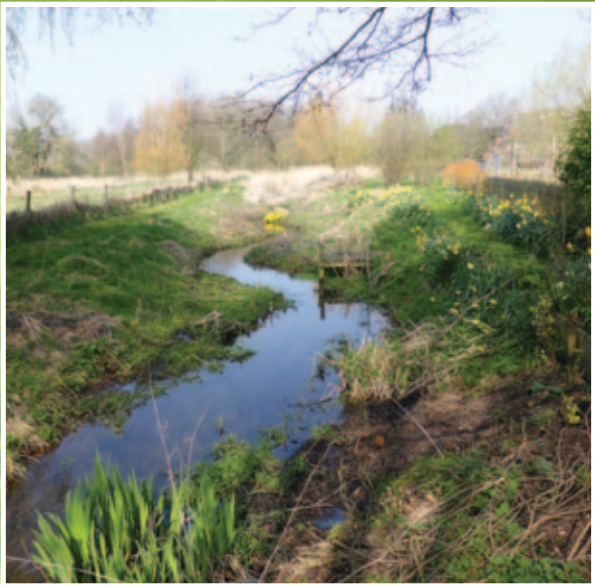
Ten years ago this section of stream was absolutely straight and featureless. Growth of plants and sediment deposition around dead plants has caused a return to a more natural meandering form, which in turn has started to cause pools and riffles to develop. (Photo: Olly van Biervliet, Fox's Beck, Norfolk. With thanks to John Dowland)

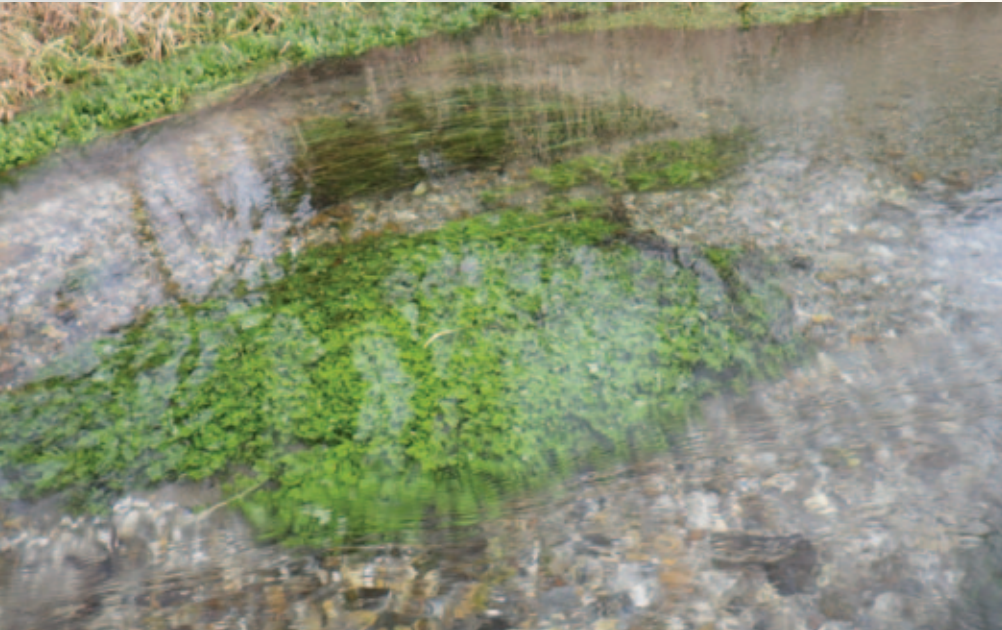
The Heacham River: a Norfolk chalk stream, having clear, lime-rich water flowing over flint and chalk gravel.

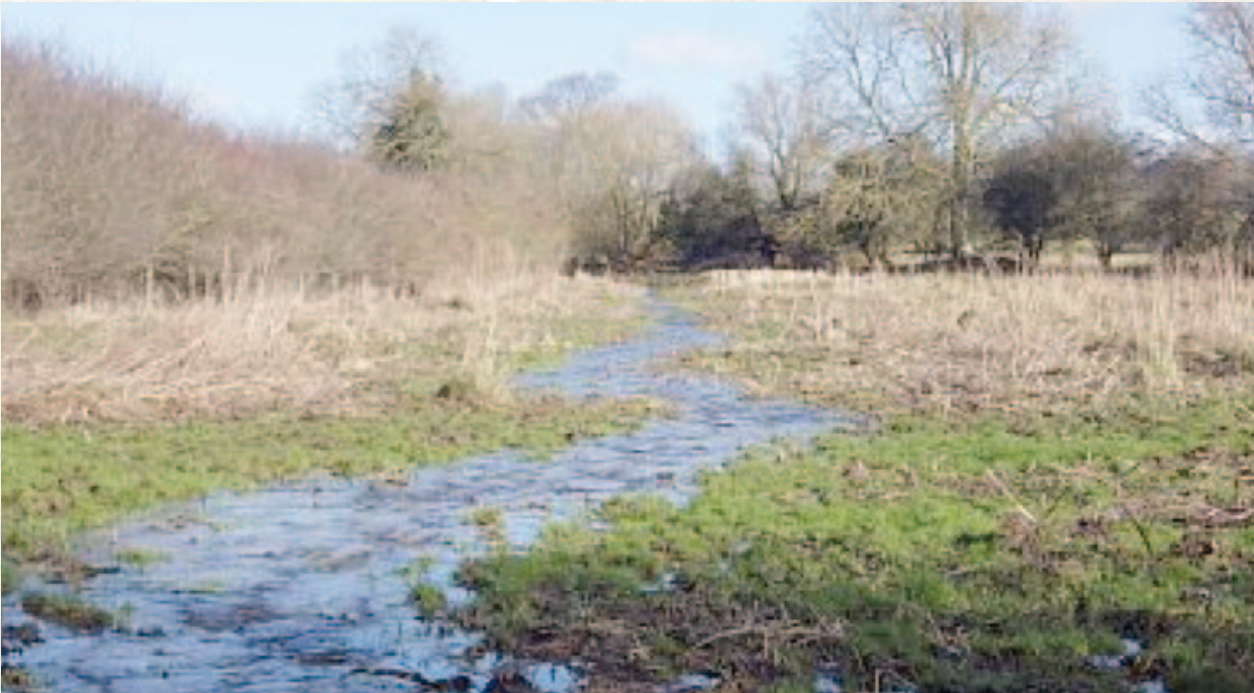
Seasonal winterbourne flow in the headwaters near Swimmer Barn, Southgate. February 2014.

winterbournes where the valley floor intercepts the water table. Flows may dry up seasonally if water levels fall in the aquifer. There is an important permanent spring near Grove Cottage at Southgate, and several intermittent sources, for example a pond near Leicester Meadow and land round Waterden (literally 'water-valley') and South Creake Common. These sources converge on the wet meadows at Fakenham Road, parts of which are designated as a County Wildlife Site. This area of confluence, which includes the Southgate Spring, may be considered as the permanent source of the river.

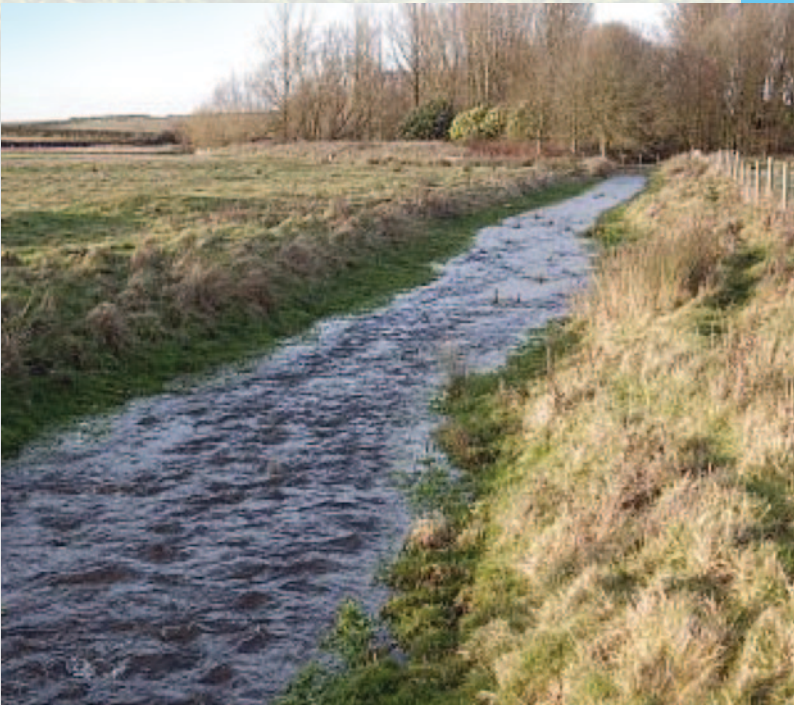
The Burn is confined by embanked dredging spoil at Abbey Farm meadows. It is prone to disappear in this stretch, due to seasonally intermittent flow.

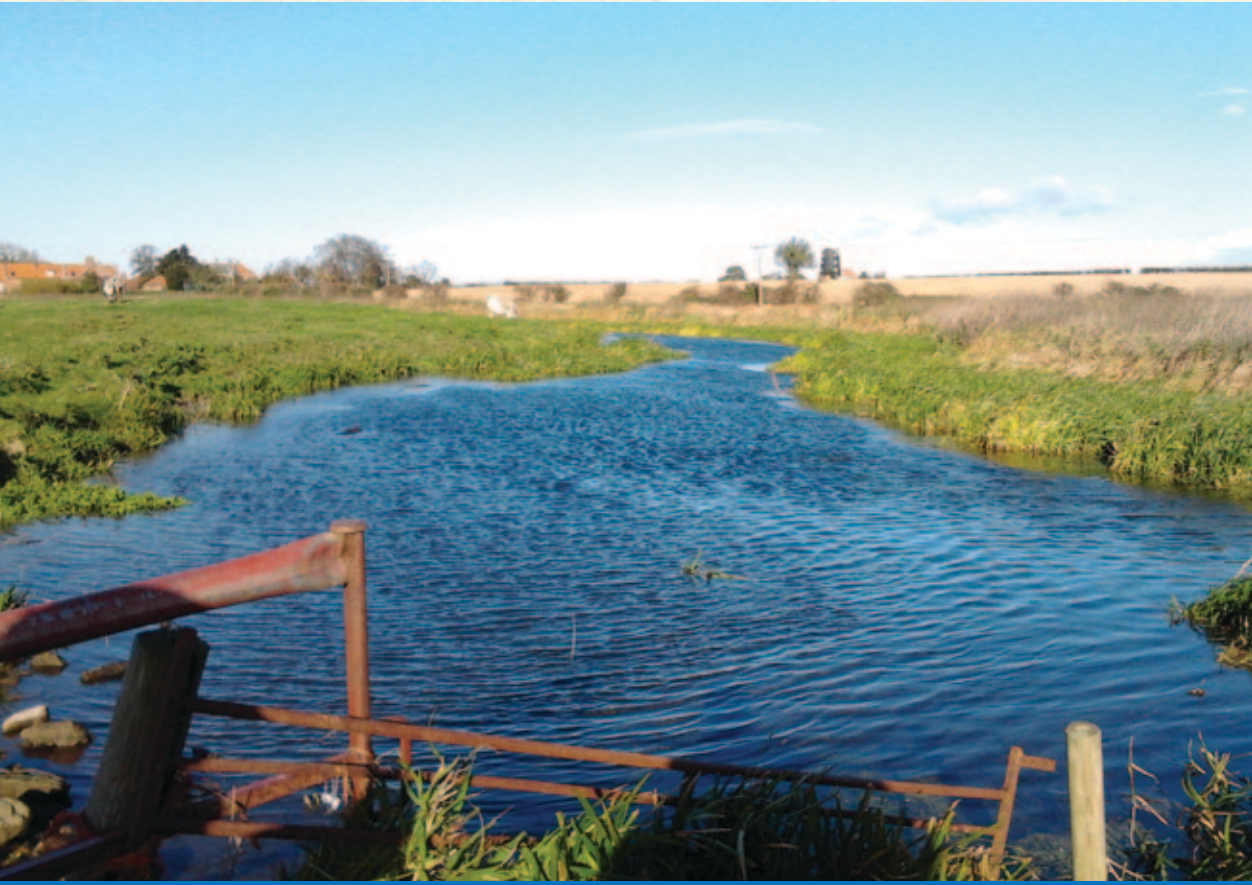
Ponded section of River Burn above National Trust Mill.

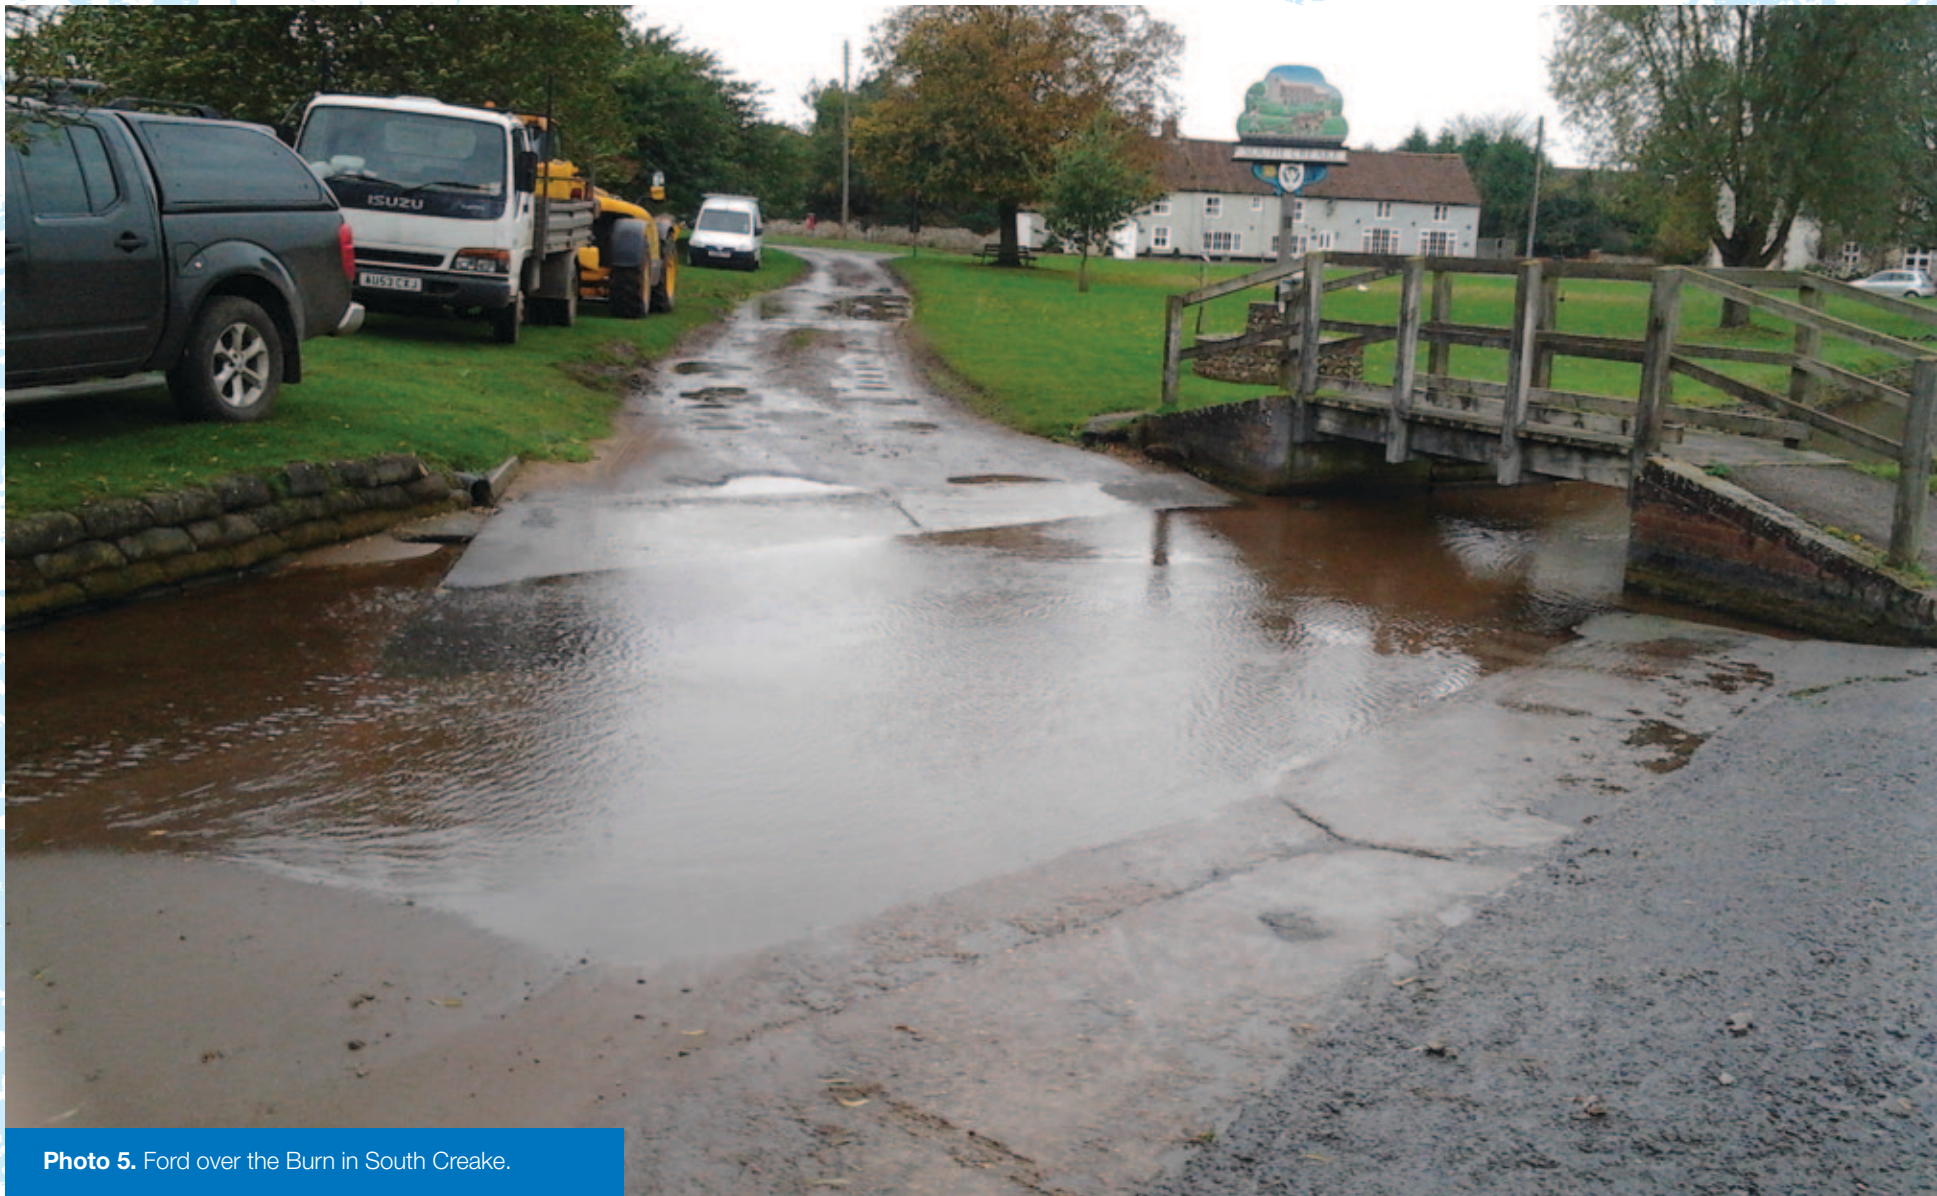
**Photo 5.** Ford over the Burn in South Creake.

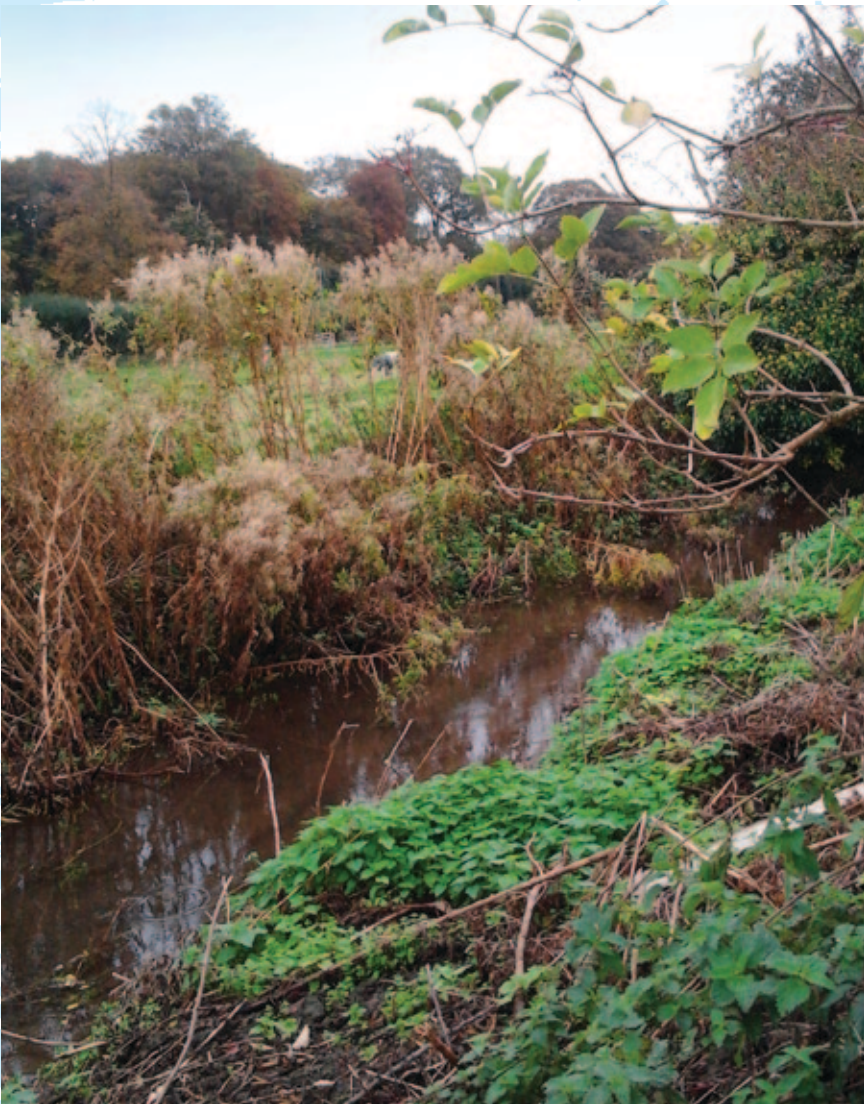
**Photo 6.** The stream becomes increasingly silted due to lack of natural stream morphology and sediment inputs.

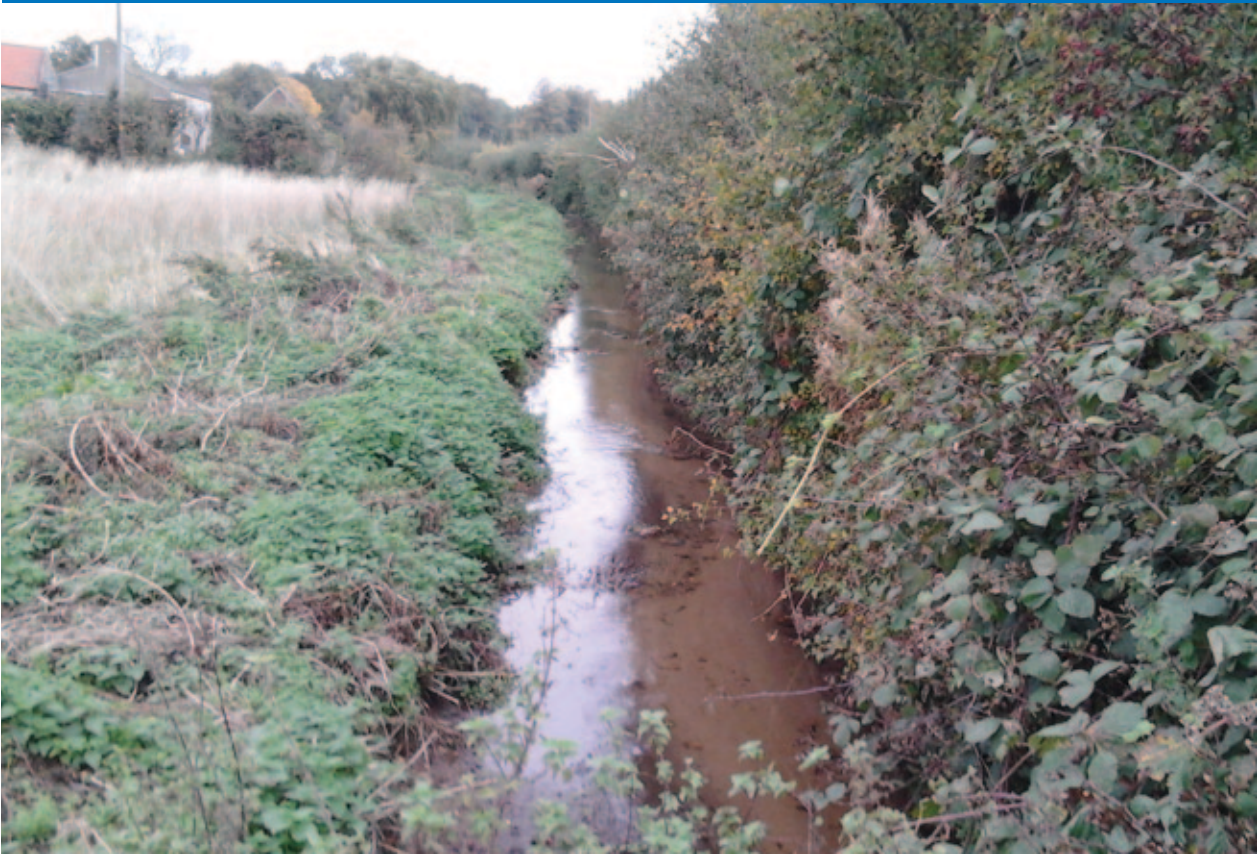
**Photo 8.** Representative section of grazed and straightened river channel. The channel banks are over-widened due to poaching and a lack of vegetation development. This results in siltation because the channel is too wide for the volume of flow, so gravels are covered in mud. In turn, this damages habitat, for instance preventing some species of fish from spawning.

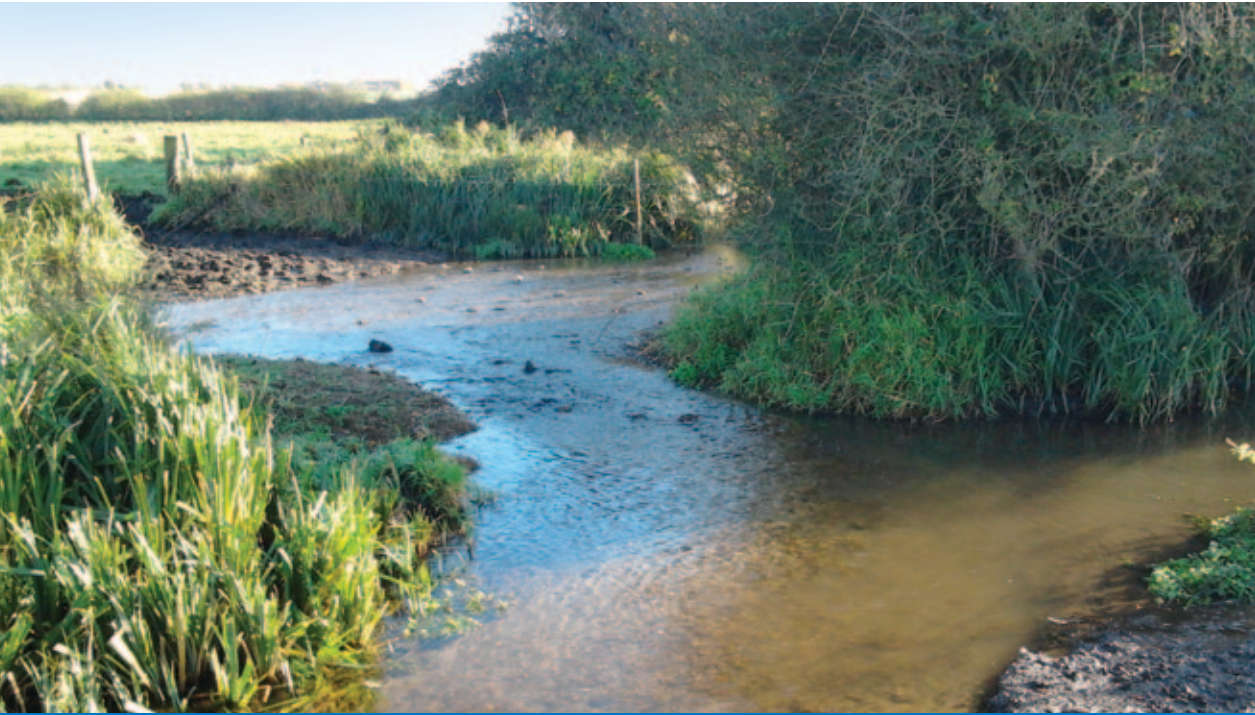
Photo 9. Spring water joining flow at Burnham Thorpe (joining from left). This adds flow and dilutes sediment load from upper Burn (right fork).

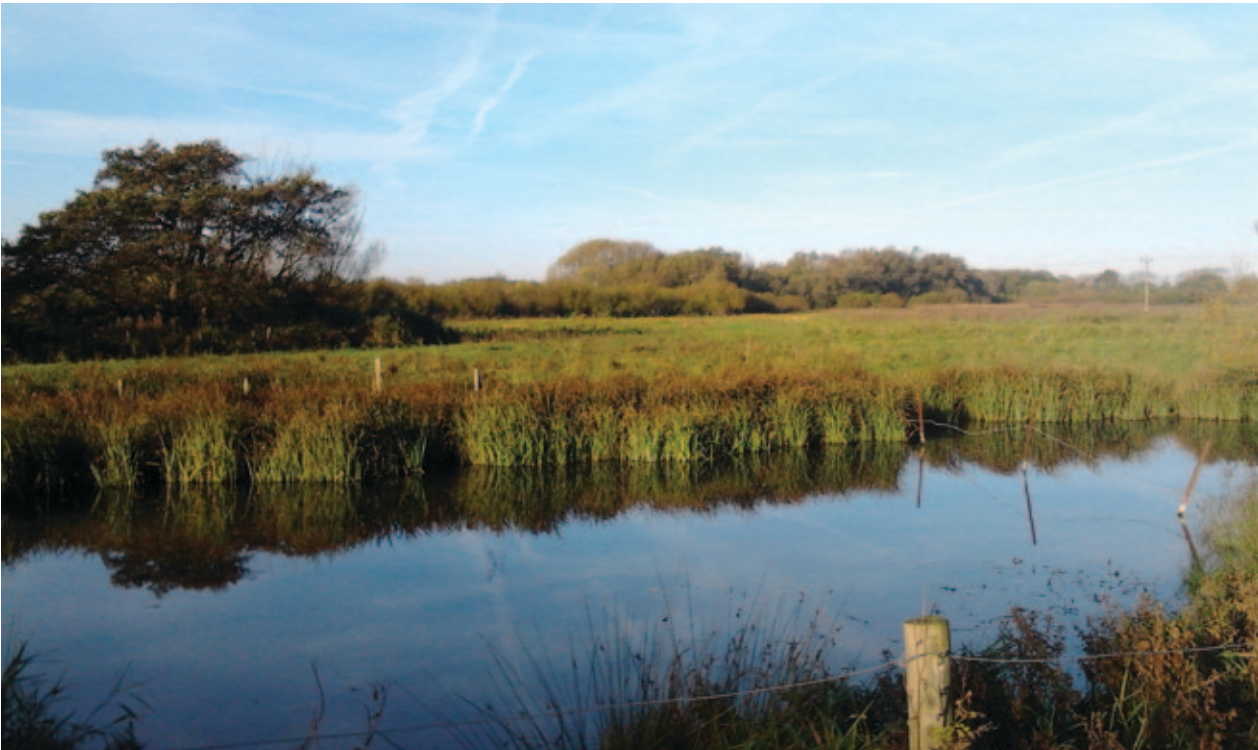
Photo 10. Springs to North of Burnham Thorpe.

Through Burnham Thorpe the river is again straightened to follow the course of the road. On the northern side of the village the stream is joined by a significant flow of water from clear springs which contribute greatly to flow and can dilute the considerable sediment load carried by the stream during rainy periods as shown in Photo 9. This input of flow gives this section of the river potential to have a thriving brown trout population, but density of trout is very low for reasons discussed later.

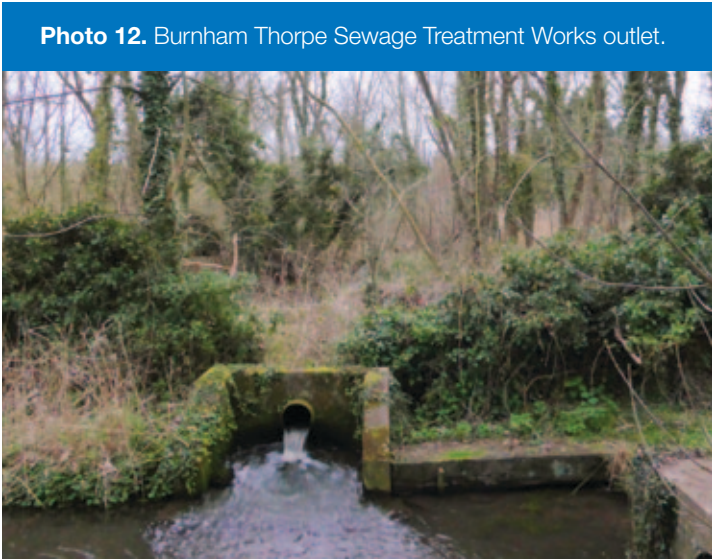
Photo 12. Burnham Thorpe Sewage Treatment Works outlet.

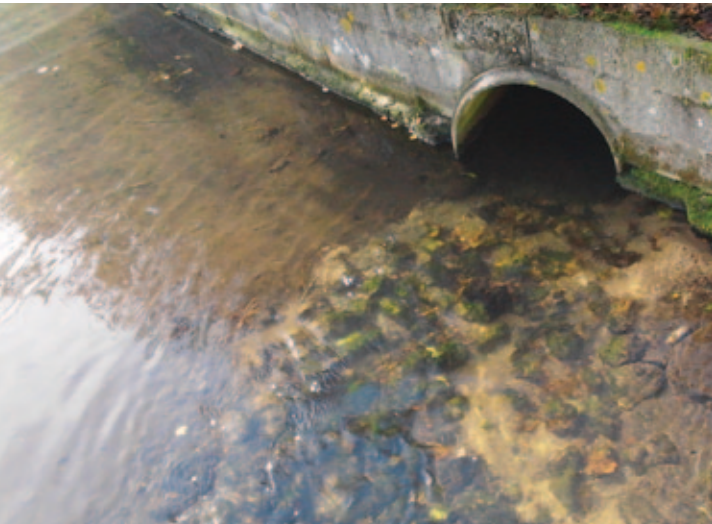
Photo 13. Outflow of channel which bypasses Roy’s Mill.

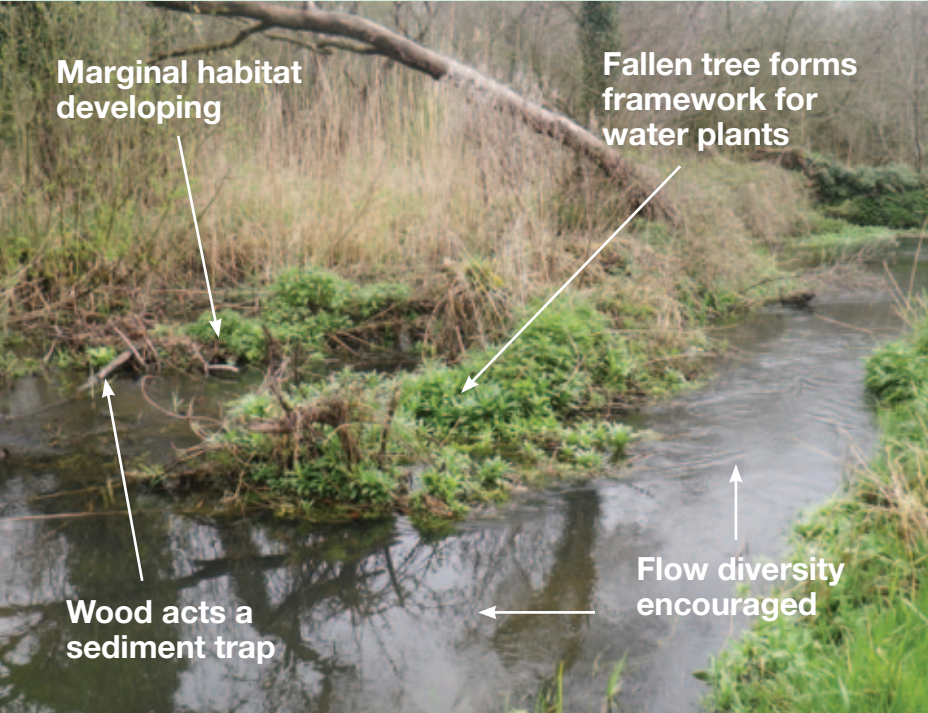
Natural tree fall has several benefits for habitat creation, channel structure and sediment modulation.

Tree acts as a hard point and has caused the development of a pool. Submerged tree roots are also excellent habitat for brown trout.

meanders to develop. Tree roots in banks provide vital habitats for a multitude of species, notably native crayfish, otters and eels. Dead trees in the river are equally important. They are a key habitat. Moreover, large dead wood (especially entire trees) initiate the natural recovery of rivers from straightening and cause flow diversity. In fact, tree planting and addition of large woody material are the most cost effective and among the most beneficial measures which Norfolk Rivers Trust undertake.

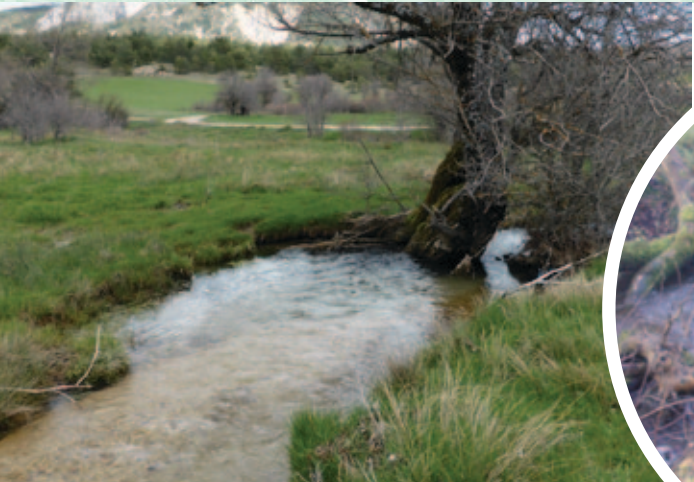
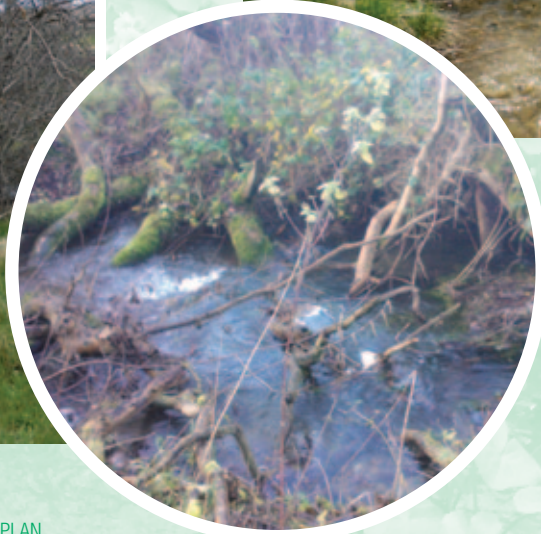
Natural tree fall has caused a great range of microhabitats and greatly increased in-stream surface area for a diversity of river invertebrates.

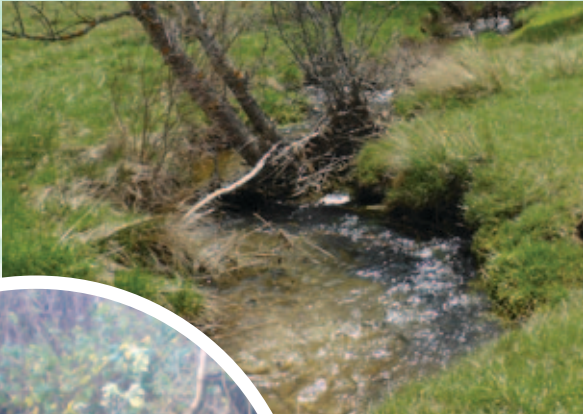
Tree acts as a hard point and has caused a meander to develop.

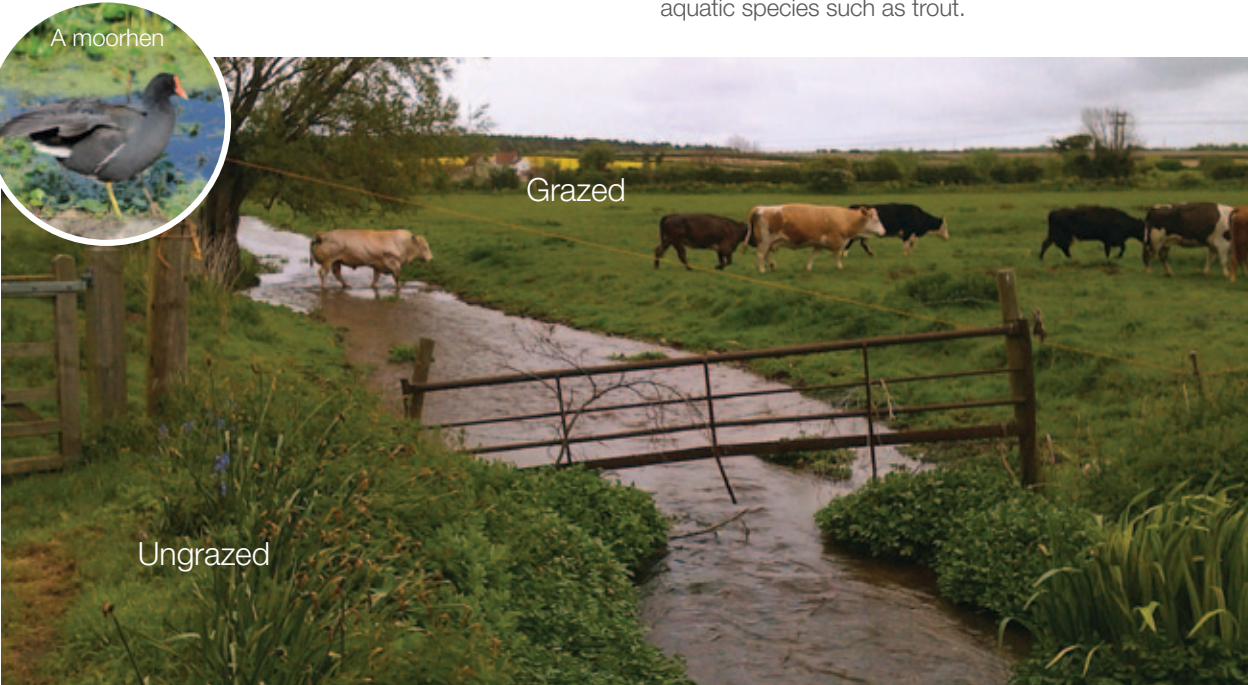
Where the river is grazed vegetation is reduced and the stream becomes overwidened. Where it is ungrazed river channel is narrowed, and this differentially scours the central channel and traps sediment at the fringes. The ungrazed area also provides excellent cover for species such as brown trout and families of morehens.

addition of large woody habitat, and reducing grazing pressure on the stream margins could be very beneficial. Sensitive gardening could also greatly promote stream functioning in sections of rivers. Natural vegetation growth can restore river processes such as a sinuous pattern, scouring of gravels, and can represent important habitats in themselves. Marginal vegetation is also vital as cover for aquatic species such as trout.

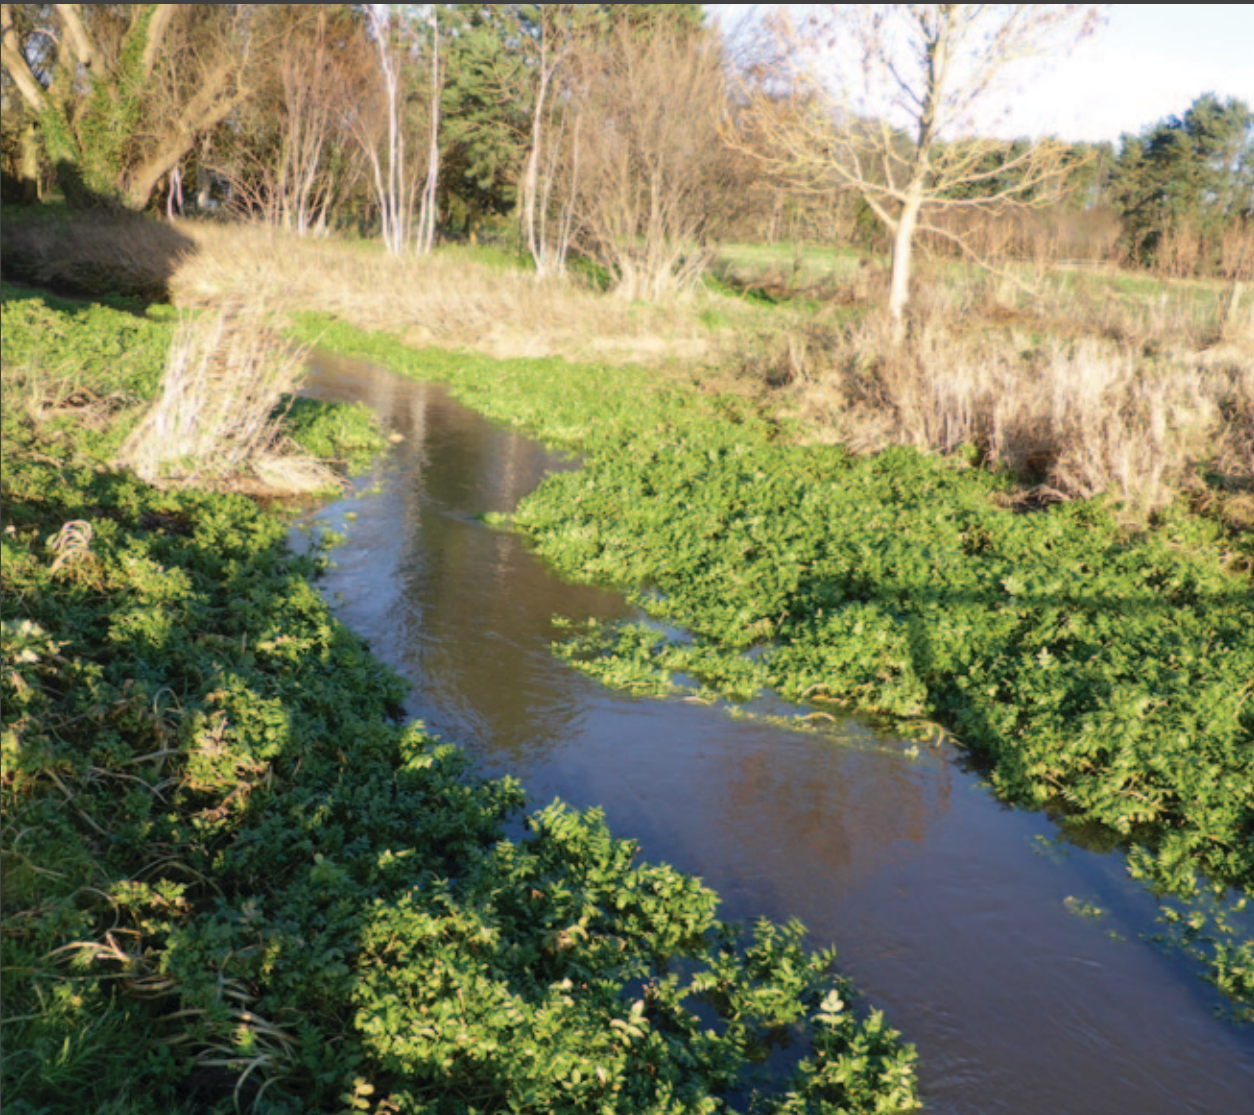
**Figure 1.** Structural modifications to streams should be based on bank full capacity (the height of common high flows) and should have sufficient flood capacity (maximal levels). If bank full capacity and sinuosity are properly incorporated, then sediment regime will also be modulated by alternate sediment storage in slow moving water and scour in faster water. This will reduce/negate need for sediment clearance.
