THE NORFOLK RIVERS TRUST
RESTORING NORFOLK'S RIVERS

THE RIVER HUN

A WATER FRAMEWORK DIRECTIVE LOCAL CATCHMENT PLAN

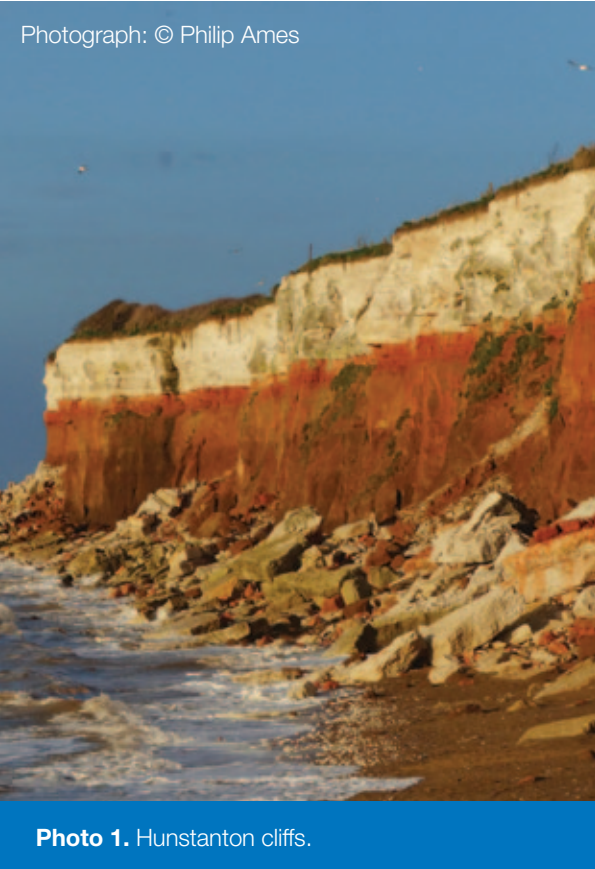
At Hunstanton Cliffs, the geological sequence is exposed. The basal Carstone is a sandstone with pebble beds. A red chalk (Hunstanton Formation) is overlain by younger white chalks (Photo 1).

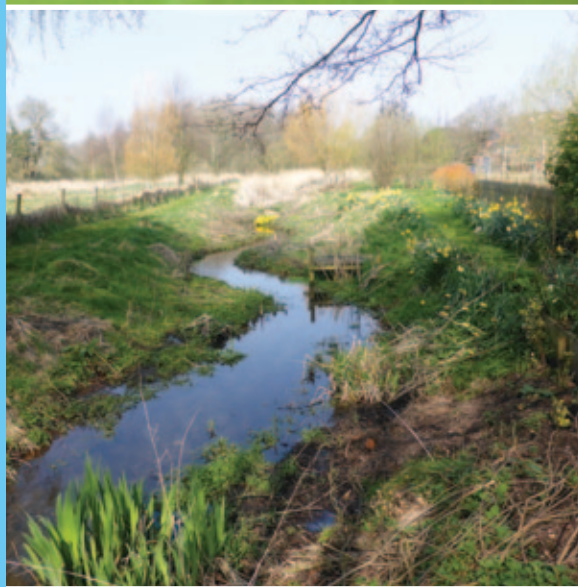
Ten years ago this section of stream was absolutely straight and featureless. Growth of plants and sediment deposition around dead plants has caused a return to a more natural meandering form, which in turn has started to cause pools and riffles to develop. (Photo: Olly van Biervliet, Fox's Beck, Norfolk. With thanks to John Dowland)

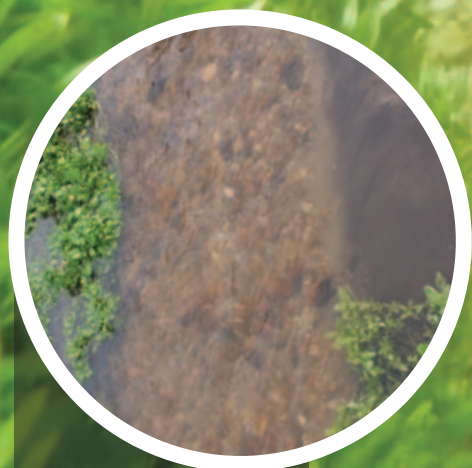
Water plants cause flow
variation which also
encourages sediment
storage and scour.

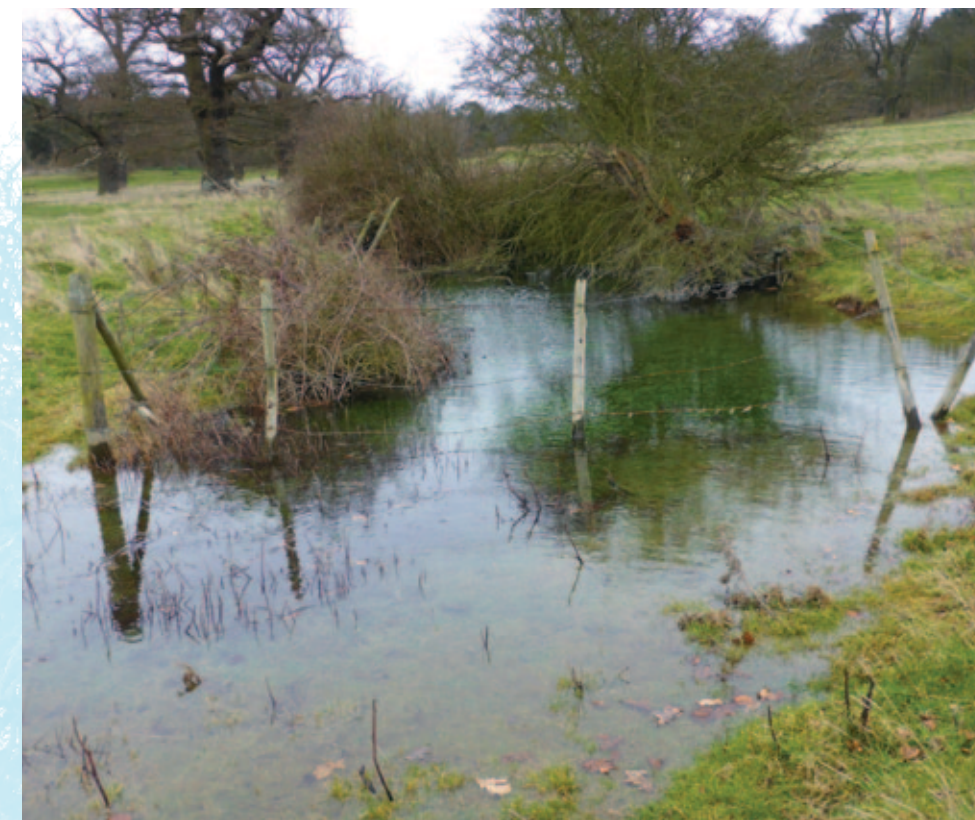
Photo 12a and b. Crystal clear water entering the Hun from an ephemeral groundwater-fed pond during higher water levels and joining the main river course.

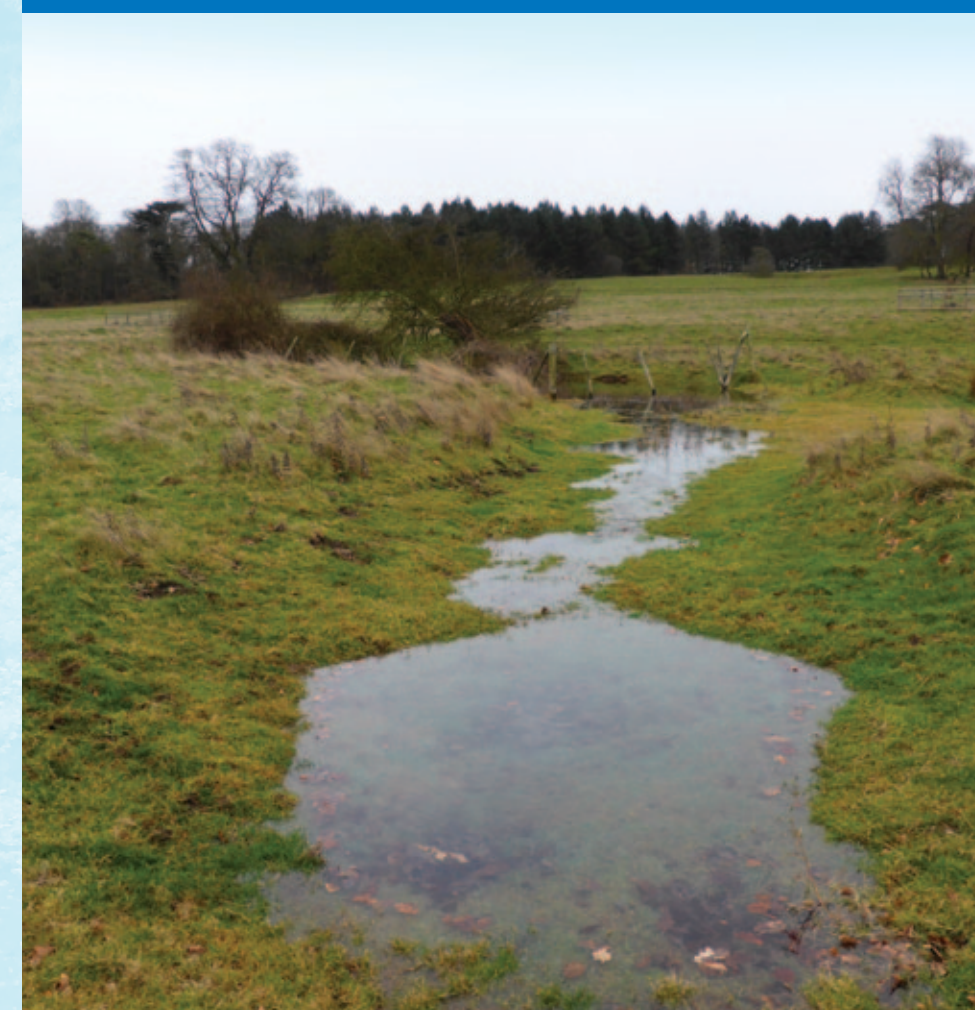
Photo 14. River in deepened and vegetated channel below the moat.

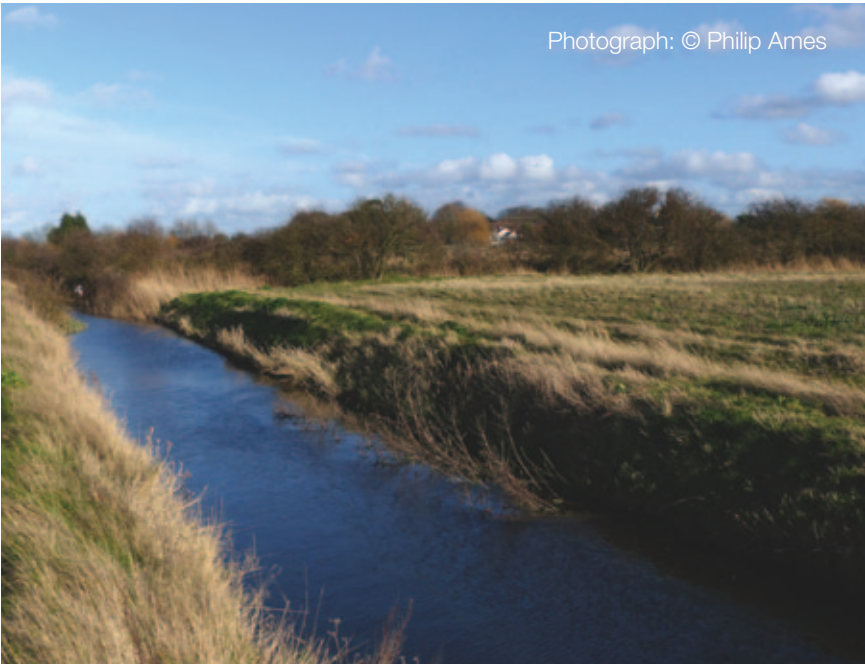
Photo 18. A representative picture of the silty and canalised lower Hun below the confluence with flows from Waterworks Road.

By contrast, the area below the confluence with the springs from Waterworks Road is straightened and artificial. In the lower river, there is a 1.3 km section of river which is absolutely straight. Little is known about the biological community of the river, due to a lack of consistent monitoring of key groups such as water plants, fish and invertebrates. However, it appears likely that these communities are very impoverished as a consequence of the poor habitat.

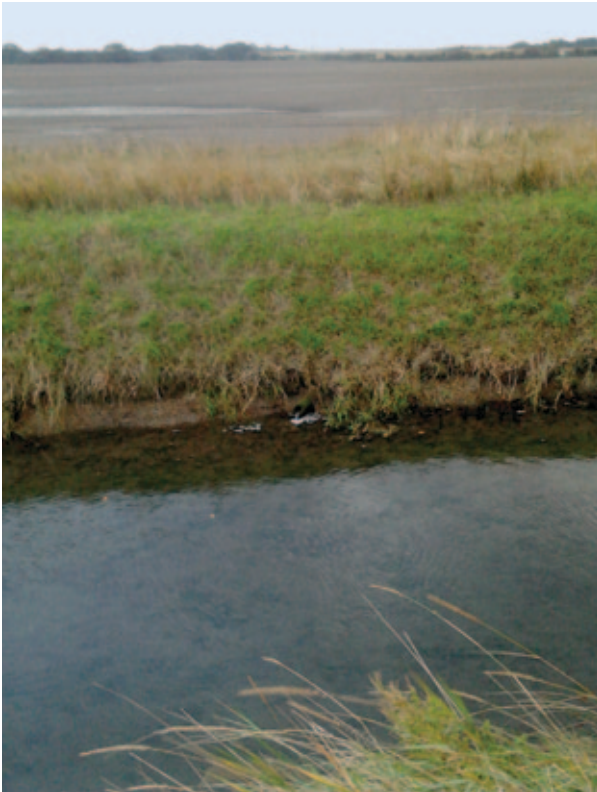
Photo 19. A representative picture of the silty and canalised lower Hun.

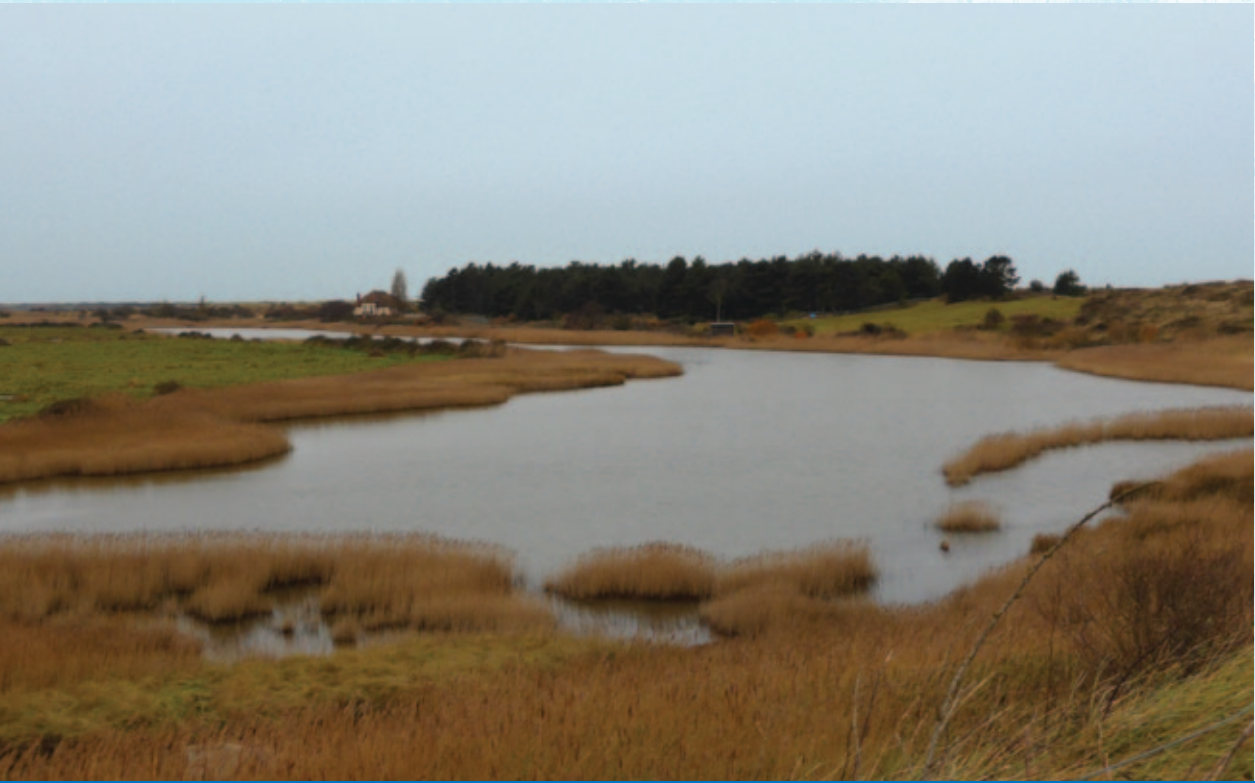
Photo 21. Broadwater, a lake which was probably a tidal meander of the river in the past.

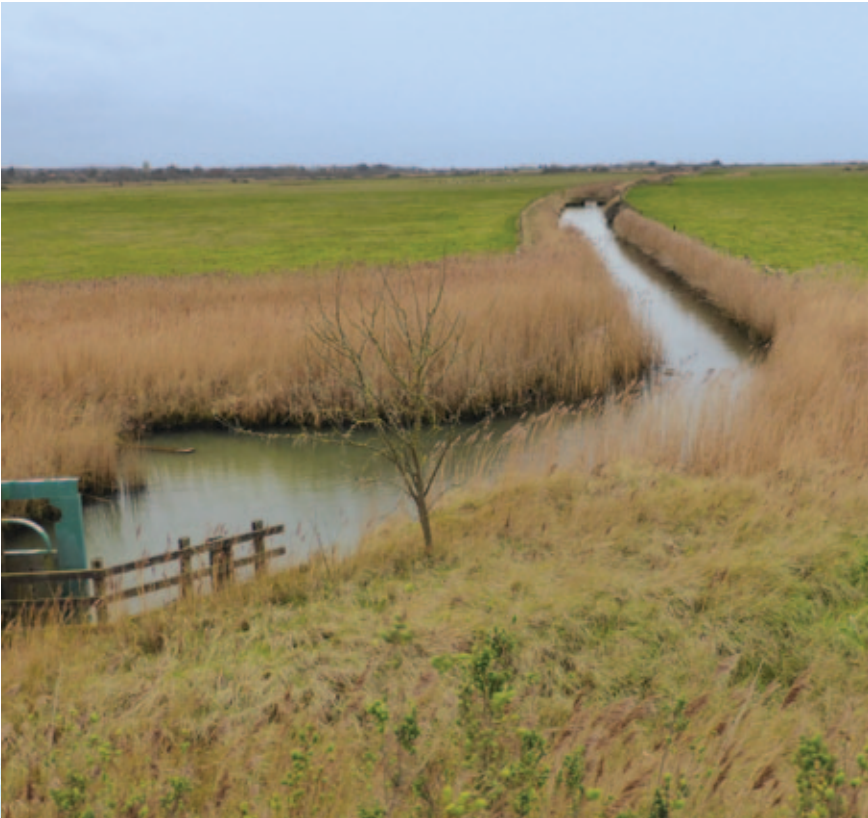
Photo 22. The Hun just upstream of the tidal sluice.

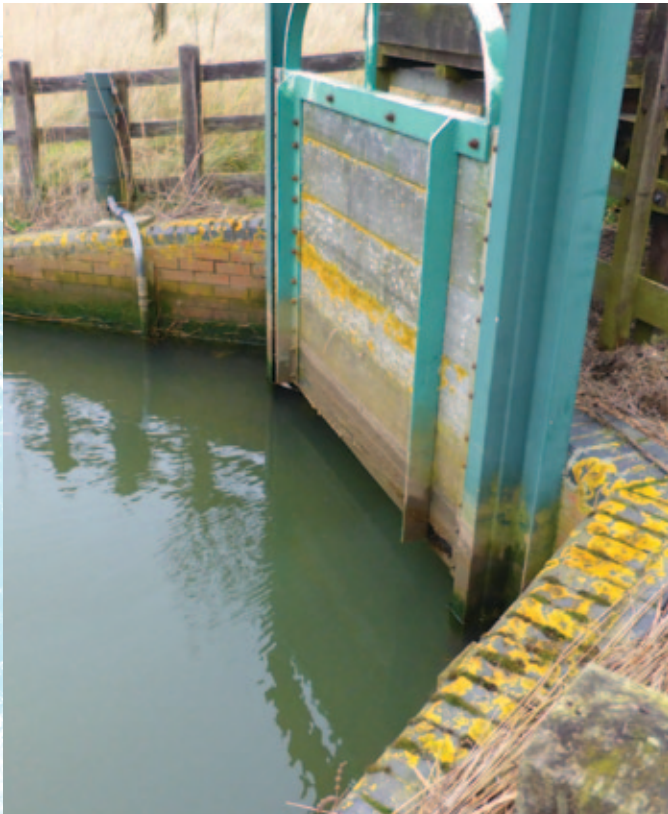
Photo 23. Tidal sluice at Hun outfall.

In terms of barriers to fish passage, the tidal sluice could represent some impediment to fish passage, however the significance of this has not been quantified. Flounder are frequently observed close to Redwell Nature reserve, demonstrating that the structure is passable.

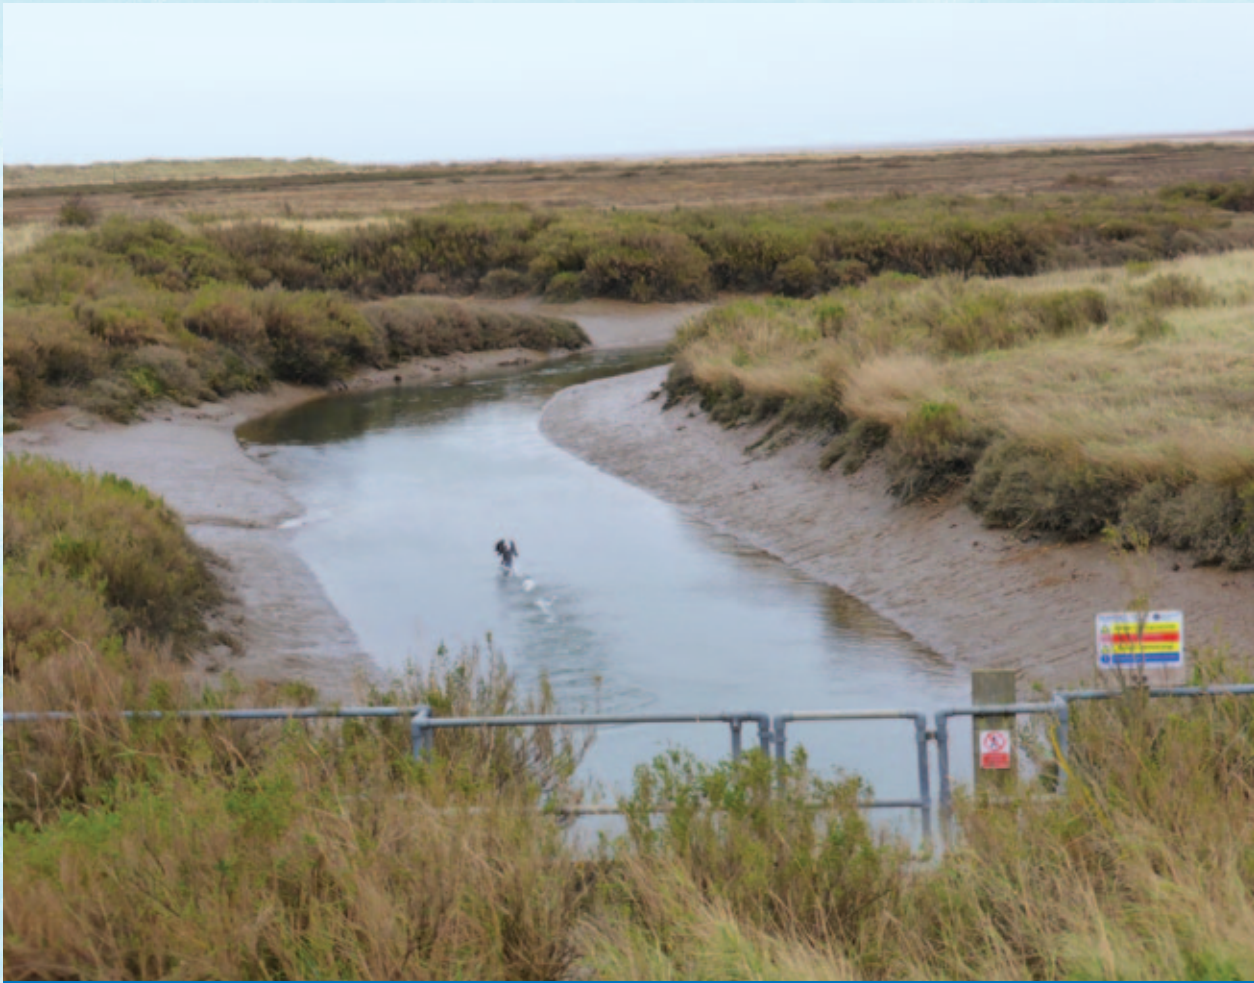
Photo 24. Tidal section of River Hun.

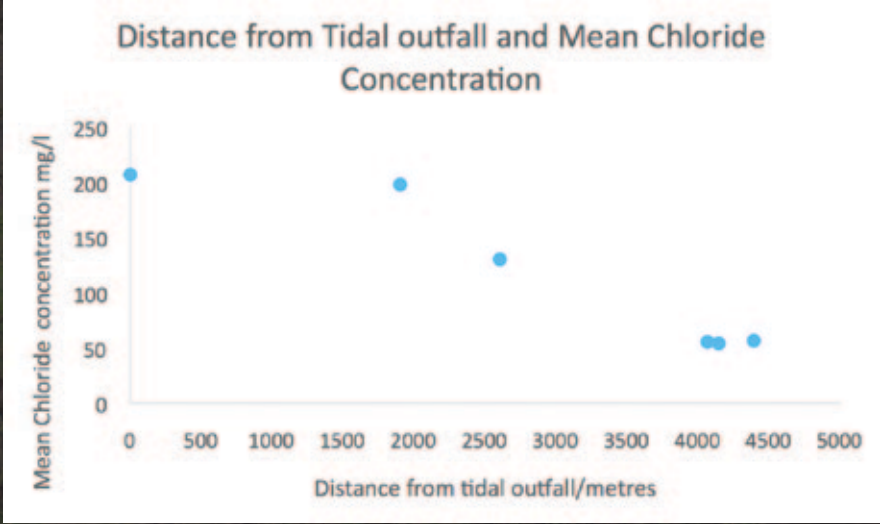
Figure 2. Salinity changes as distance from tidal sluice increases. Sea water has a concentration of around 19,000 mg/l of chloride, and concentrations in the low hundreds are not thought to be damaging to wildlife such as plants or invertebrates.

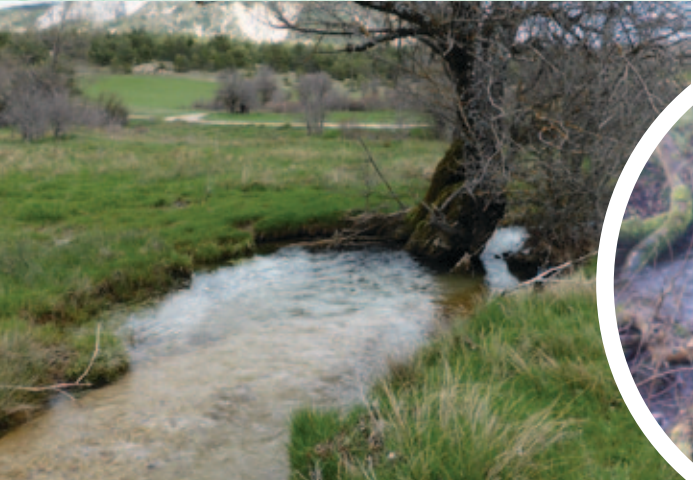
Tree acts as a hard point and has caused the development of a pool. Submerged tree roots are also excellent habitat for brown trout.

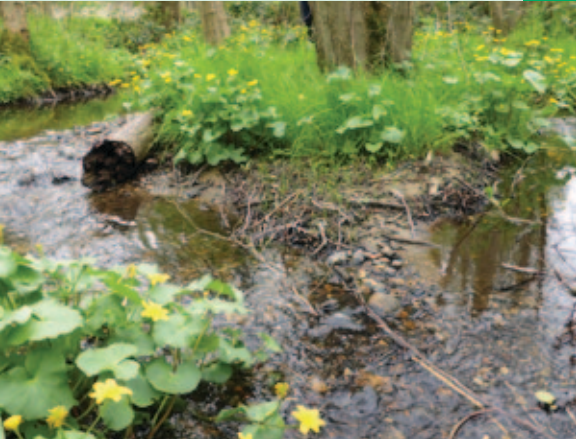
Natural tree fall has caused a great range of microhabitats and greatly increased in-stream surface area for a diversity of river invertebrates.

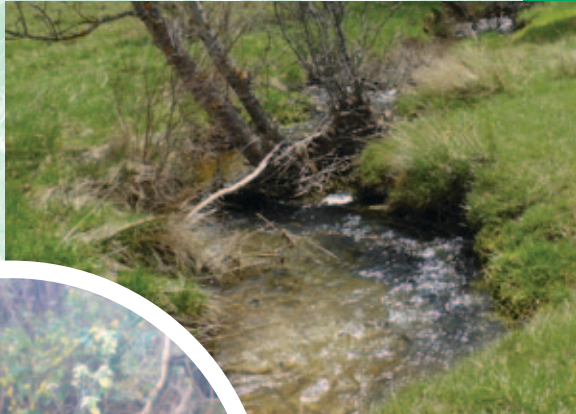
Growing trees have changed this former straightened drainage channel into a river with a more natural structure and in-stream islands (*anastomosing channel*).

Tree acts as a hard point and has caused a meander to develop.

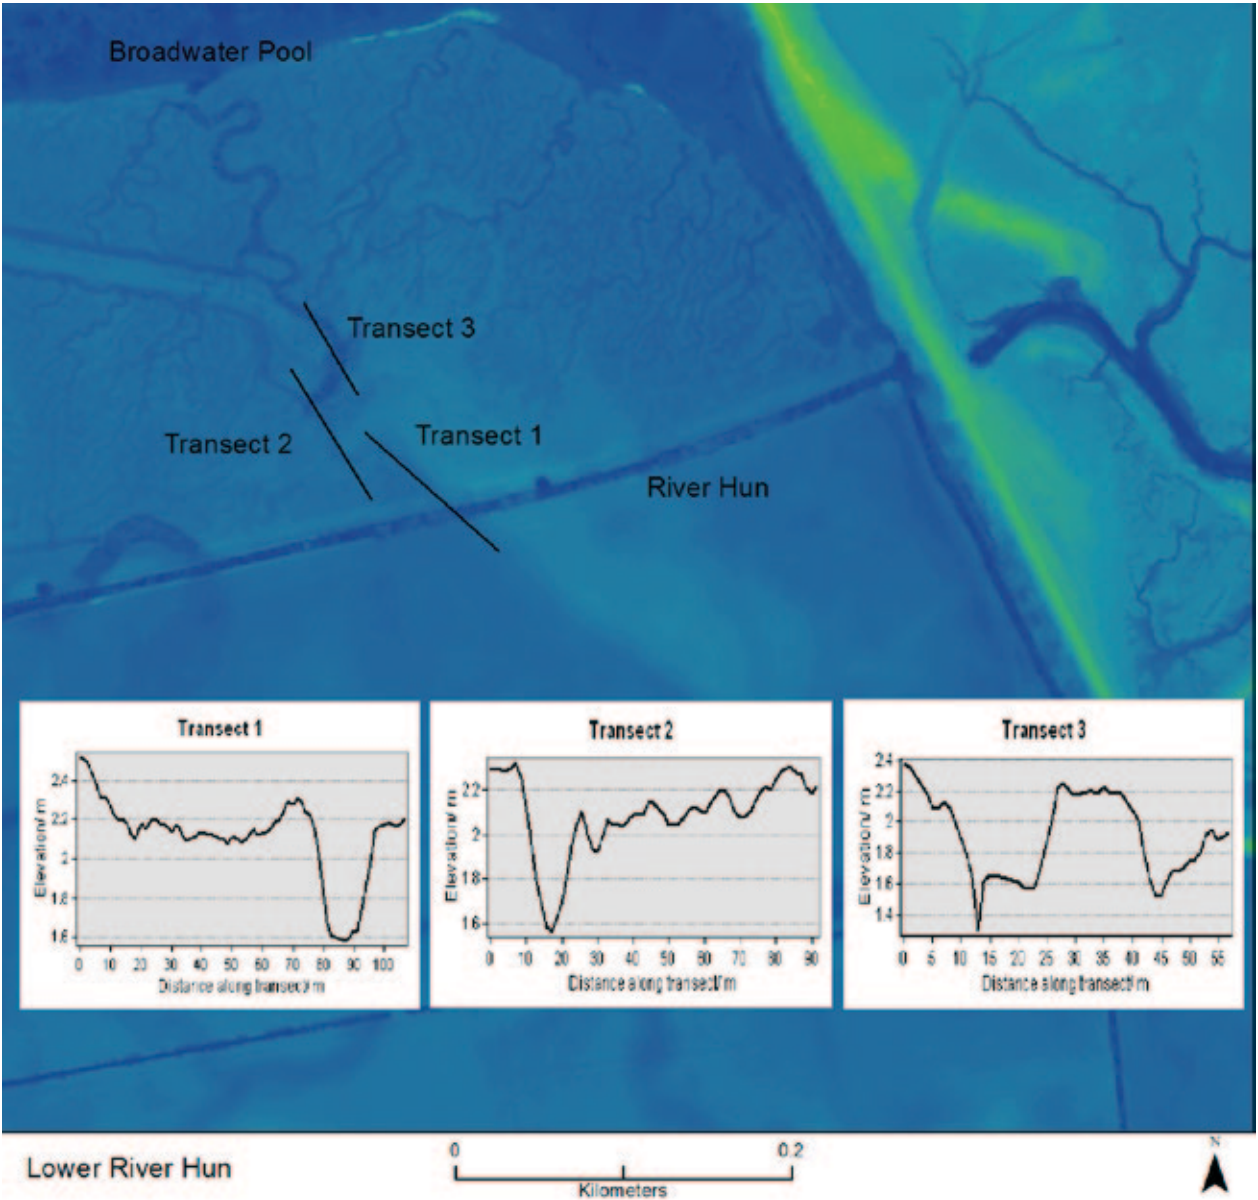
Figure 3. Elevation analysis of River Hun in Holme Nature Reserve to assess the feasibility of re-wetting historic tidal creeks to improve bird habitat. Green areas are of higher elevation and increasingly dark blue areas are lower. Cross sections are taken left-right looking downstream as is standard practice. The area pictured is about 290 metres upstream of the tidal sluice. Because the creeks under examination historically originated from the Broadwater side it can be seen that they are in fact of greatest elevation closer to the river and reduce in elevation as they approach Broadwater. As a result once water has reached the creeks from the river system it will easily flow to fill the rest of the creek system. Bunds to protect Broadwater from filling from the river would need to be checked. To fill the creeks as they stand, a 50-60 cm increase in water levels and removal of what appears to be a bund at the top of the creek system would be required. It may be that this increase in water levels would be excessive. In this case, some physical work to lower the bed of the first section of the creeks would be needed to allow the water to flow into the rest of the system. This will mean that less of an increase in water levels would be needed.

In the lowest part of the river, reconnection with historic meander bends of the river (visible in Figures 3 and 4) might be desirable in the long term if flood defences were retreated ("managed realignment").

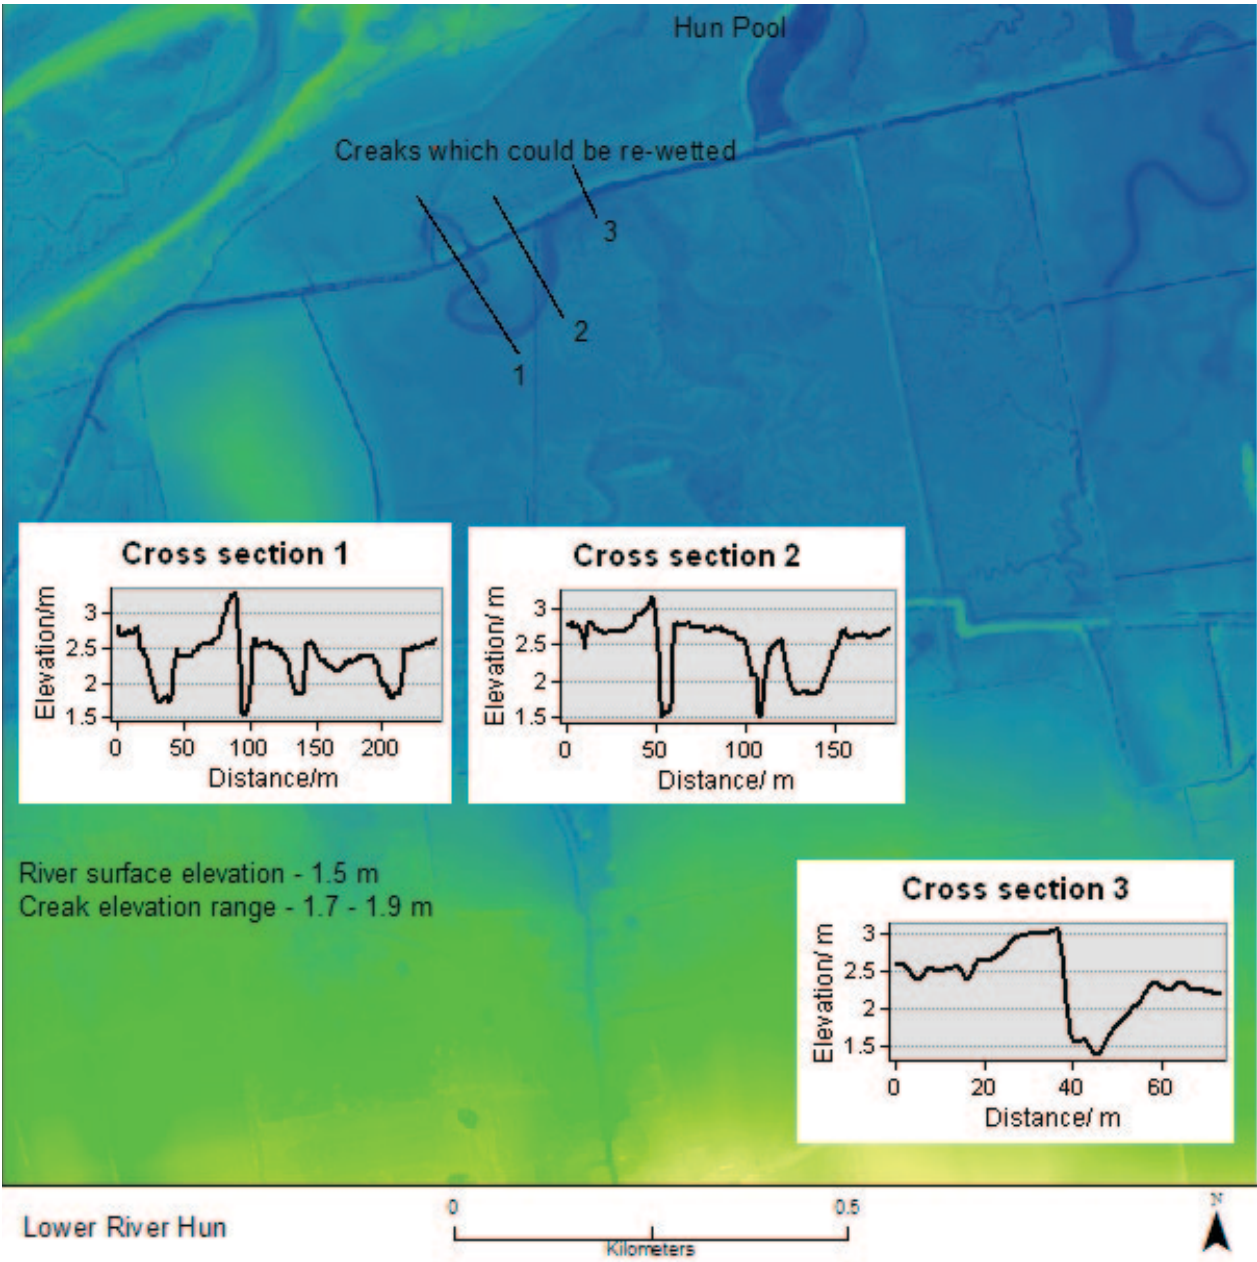
Figure 4. Elevation analysis of another area in the River Hun in Holme Nature Reserve. Green areas are of higher elevation and increasingly dark blue areas are lower. Cross sections are taken looking downstream as is standard practice. They show that river Hun is lower in elevation than the historic of the creeks by 0.2 – 0.5 metres.
